Non-Hermetic Impulse Cartridge Failures: “A Case Study”

George R. Neff* and Jimmie K. Neff**
IsoVac Engineering, Inc., Glendale, California

This paper is addressing the findings in a Case-Study investigating a group of BBU-36 Impulse Cartridges purchased by the Air Force and later found to be defective. This study is reviewing the problem “Generically” in order to disseminate the findings to those experiencing similar performance problems in other ordnance devices, and, hopefully stimulate changes that will avoid such problems in the future. This Case-Study has uncovered some major weaknesses in: a) The design of the device; b) The materials used in the manufacture of the device; c) The manufacturing processes used; and d) The test procedures used to evaluate the finished product.

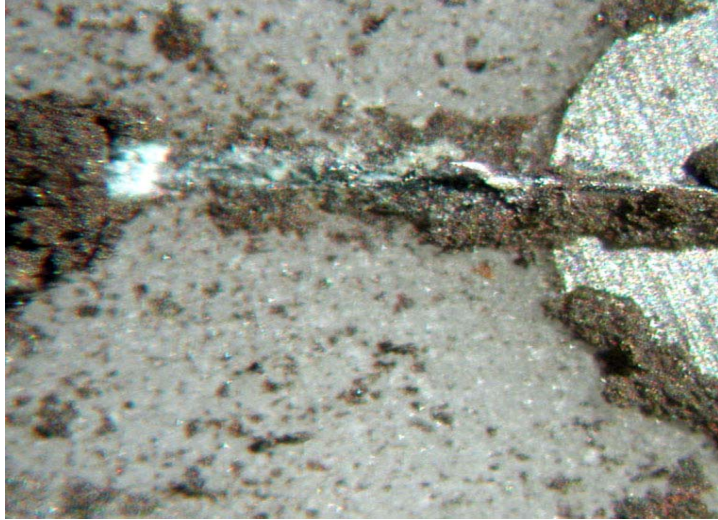
A number of non-functional ordnance Impulse Cartridges were found to exist in the field. This case-study involved an extensive investigation of those devices to establish the nature of the defects that caused them to malfunction or fail, and the root cause for the devices to have been defective. The impulse cartridges were built to an Air Force Specification SP7730680C, and found to involve several design characteristics that made the devices vulnerable to both manufacturing difficulties as well as misapplied hermeticity test methods. A series of investigations was conducted that included chemical and engineering studies, as well as a detailed investigation of the hermeticity of the devices. These cartridges had two separated chambers of concern: a loose powder chamber containing ordnance pellets, and a compressed charge chamber that pressed against the header and encapsulated the bridge-wire. The two chambers were located at opposite ends of the devices, and some devices were found to have leaks into each end. The conventional helium seal testing methods were able to detect some defective seals into the larger cavity pellet chamber, but were incapable of detecting the leakage into the micro-cavity bridge-wire area. The cartridges were also found to contain corrosive materials within the device. Two sources of corrosive material were suspected to have contributed to the failure of the devices. Acidic residues that were possibly left from the plating and chemical coating processes were found within some of the devices. The defective seals allowed leakage into the devices, which provided a means for moisture to enter the part. The moisture coupled with the corrosives within the devices caused an attack of the dissimilar-metal surfaces including the bridge-wires, which in some samples were completely destroyed. Chlorides were released perhaps from the breakdown of the ordnance material. A typical example of the total corrosive destruction of the bridge wires is shown below in Figure 1.

Figure 1
The above photomicrograph shows the effects of the complete corrosion of the bridge-wire, (typical of the findings in these cartridges)

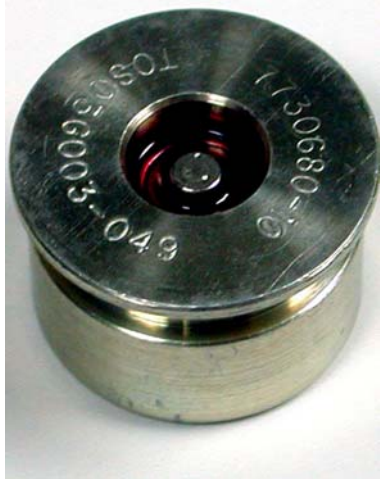
Figure 2

The type of problem seen in these cartridges is frequently associated with hermeticity problems.¹⁻⁷ Forty of the samples were investigated to establish the integrity of the seals. Twenty-nine of the forty cartridges had ‘Open-circuits’. By design the device has two seals: One is a crimp closure over the chamber that houses two types of loosely packed ordnance pellets; and the other seal on the opposite end is a ‘pressed-fit’ header seal to a chamber that holds a compressed ordnance charge. The device configuration is seen in Figures 2 & 3.

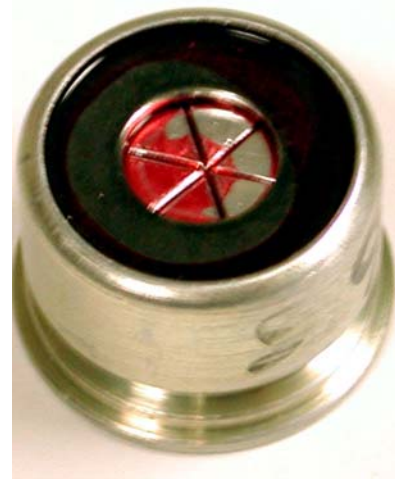
Figure 3

BBU-36 Cartridges studied in this effort.

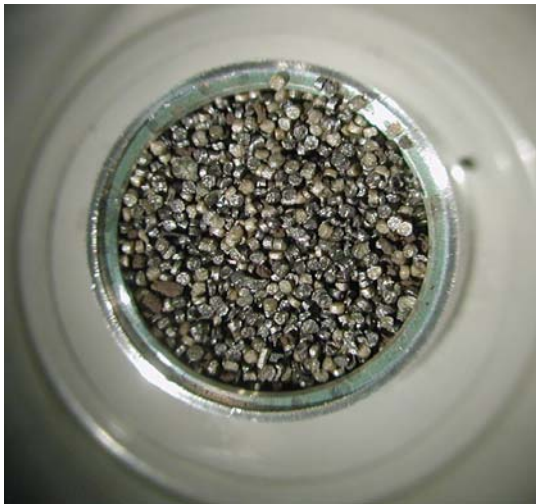
The “Pellet-Chamber” & “Compressed-Charge-Chamber” are shown below. Figure 4 shows the loosely packed pellets with ‘intra-pellet’ cavities. Figure 5 shows the compressed charge in the lower ‘header-chamber’ (after the pellets were removed).

Figure 4
Loosely packed pellets in the ‘pellet chamber’

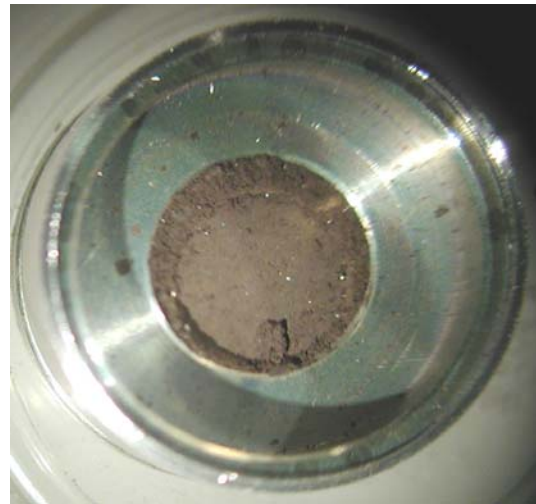
Figure 5
Ordnance compressed onto bridge-wire

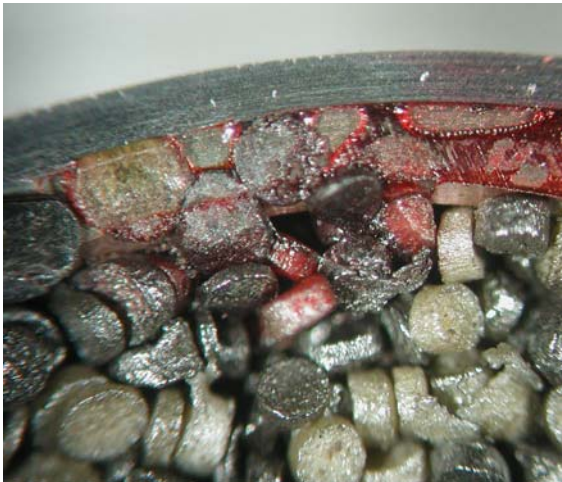
- Each pellet chamber that failed Kr85 gross leak, also showed red-dye entry. (Figure 6).
- Many crimp seals were compromised by the entrapment of pellets under the aluminum cruciform and steel washer. (Figure 7)
- Substantial amounts of varnish were found to have leaked into some pellet chambers.
- The varnish flow into the pellets on the crimp shoulder actually created a seal on some parts.

Figure 6
Red-dye leakage into pellet chamber

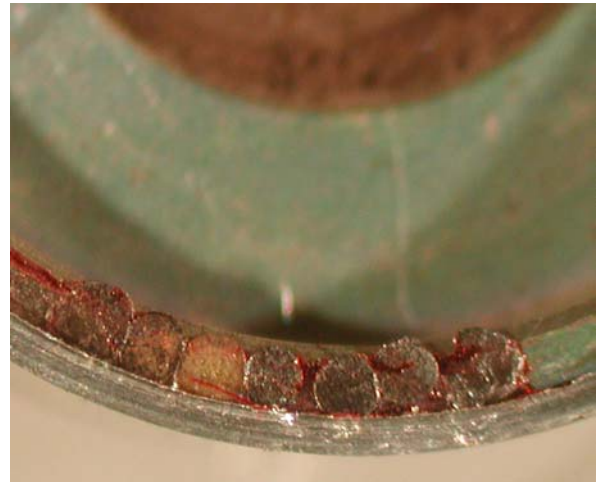
Figure 7
Pellets trapped under crimp seal

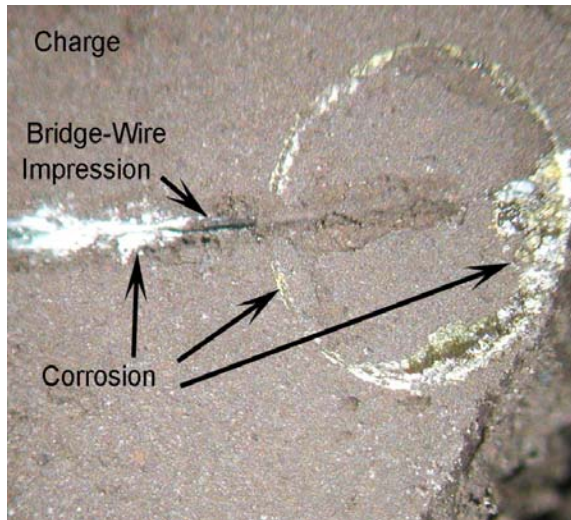
Figure 8

- The corrosion was evident on the compressed charge surface in contact with the header. (Figure 8). This compressed charge was removed from contact with the header, turned over and photographed. It was also impregnated with Kr85.

Corrosive residue on compressed charge surface

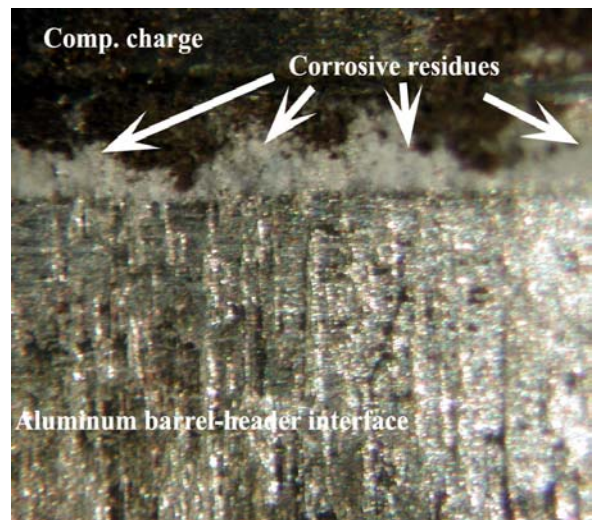
Figure 9

- The header was inserted into the aluminum barrel as a “press-fit”. The cartridge was cross-sectioned, the header removed, and the aluminum-header interface examined. The aluminum surface showed a combination of abrasion followed by corrosion. Corrosive and/or acidic residues were also found at the interface between the header body and the compressed charge. (Figure 9.)

Corrosives at compressed charge/header interface

- The steel header had been pressed into the plated or chemically treated surface of the aluminum barrel. The header scraped off the coating of the aluminum body, (as well as some aluminum), exposing bare aluminum and creating a ‘dissimilar-metal’ junction which appeared to have then corroded. (Figure 9 & 10)
- It is assumed that the chemical treatment of the aluminum body was not properly cleaned, and corrosive residues were left inside the cartridge. (Figure 9)
- The corrosion of the aluminum-header interface created gross-leaks into the B/W zone. Red-dye was found leaking into the cartridge through those passages. (Figure 11)
- Red-dye was found to have leaked through one pin-glass seal. (Figure 12)
- Red-dye was also found to have leaked through a header-glass seal. (Figure 13)

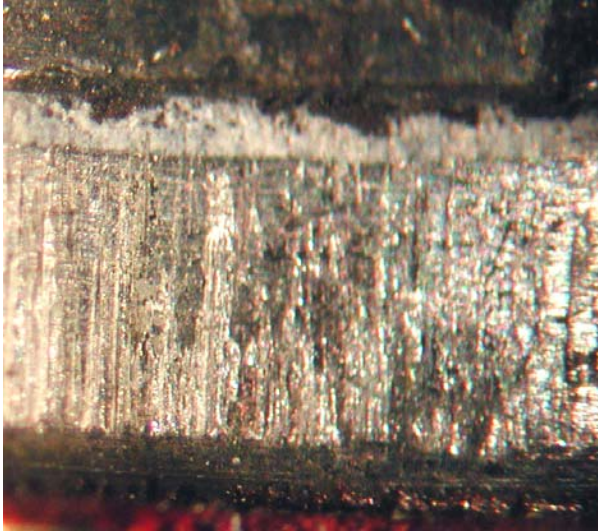
Figure 10
Corroded aluminum surface at header interface

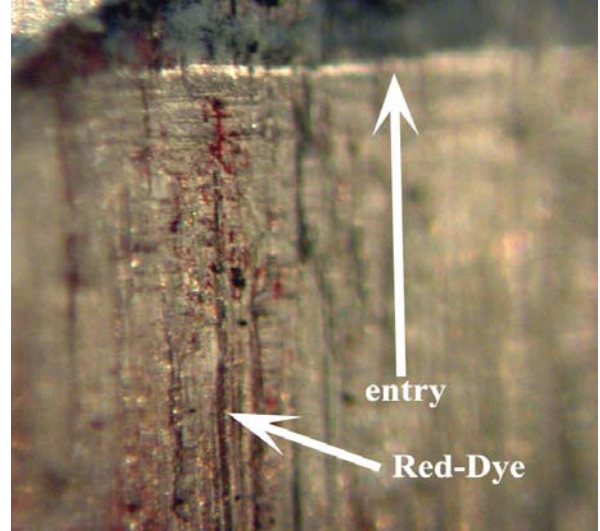
Figure 11
Red-dye leakage into compressed charge chamber

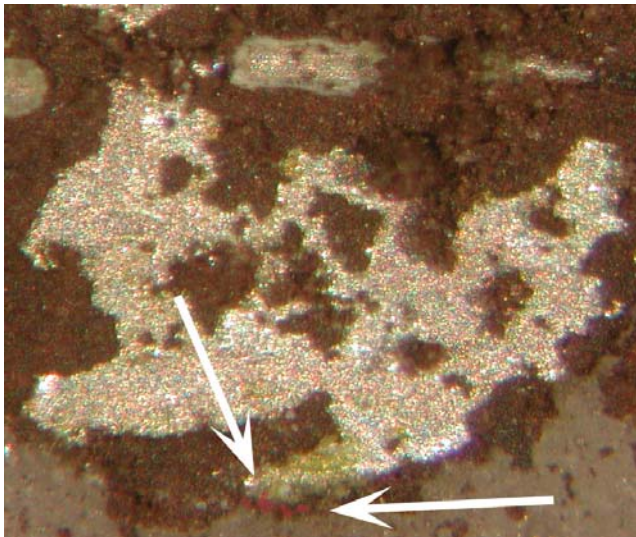
Figure 12
Corrosion on pin and Red-dye entry at pin-/glass seal

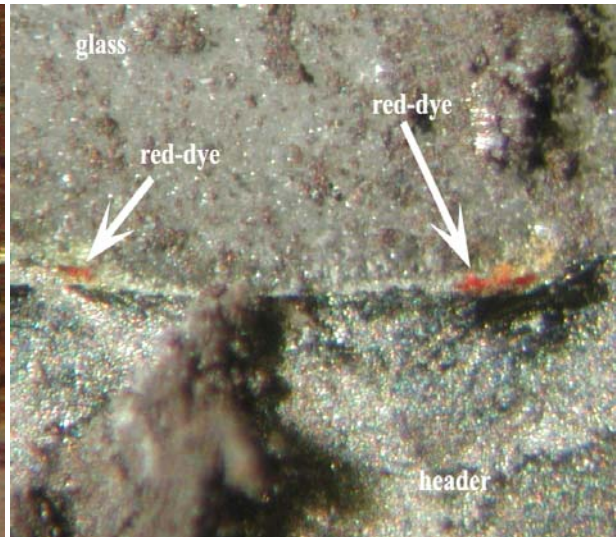
Figure 13
Read-dye entry at glass/header interface
